HYDROSTATIC AND IMPLOSION TESTS

**UAM-ARATZ "SPANISH"**  
STAINLESS STEEL COVER  
TESTING RESULTS

HQL 2018 - Yamagata, May 29th 2018

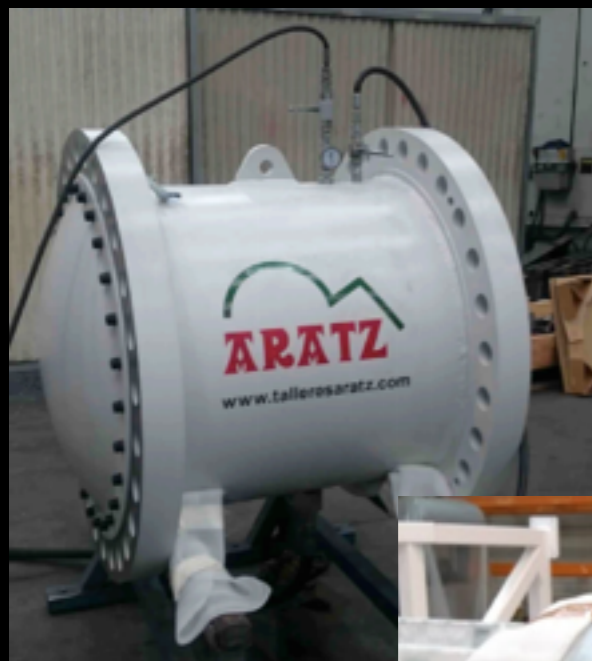
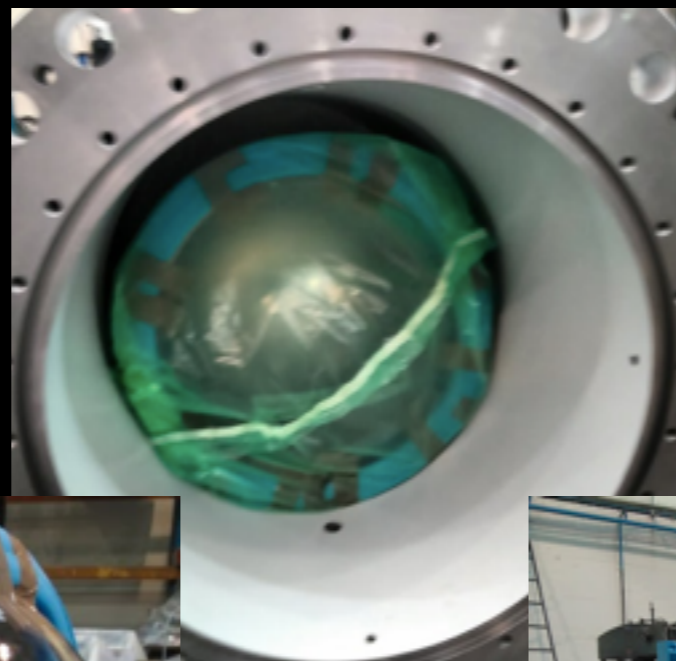
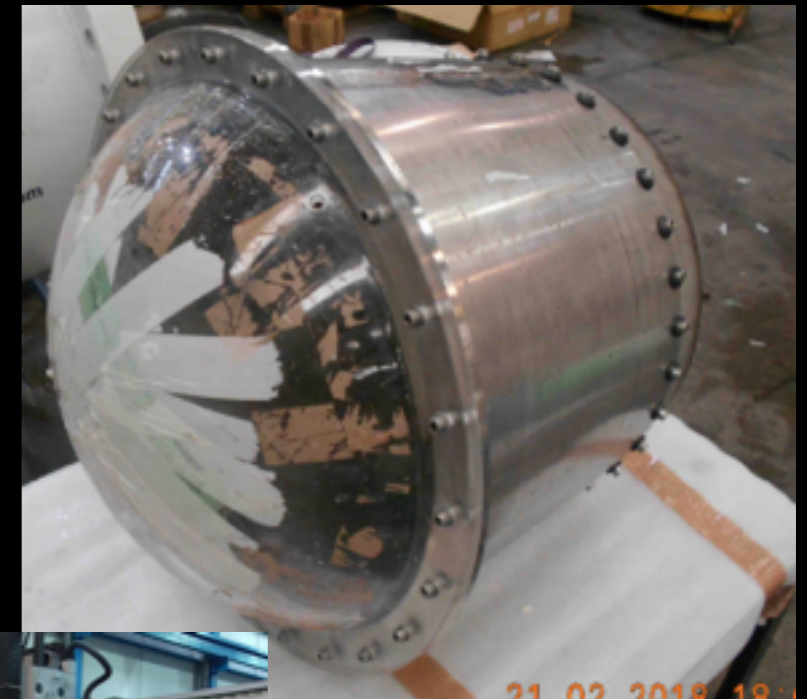
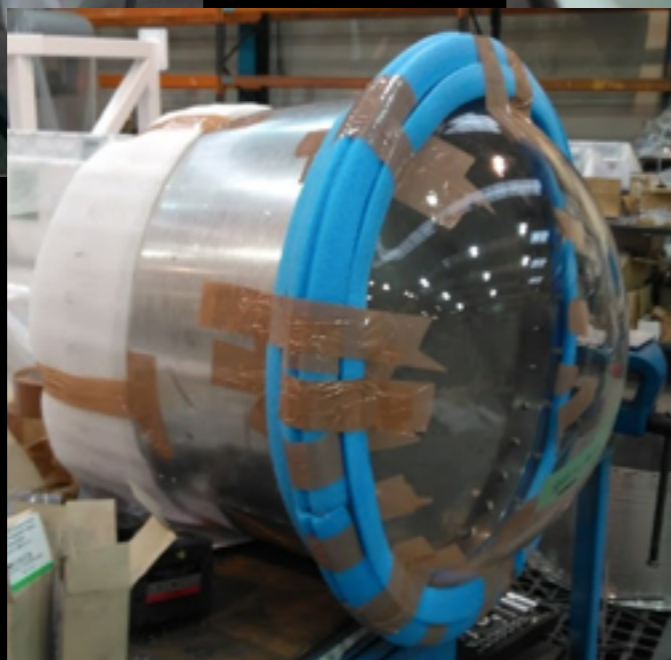
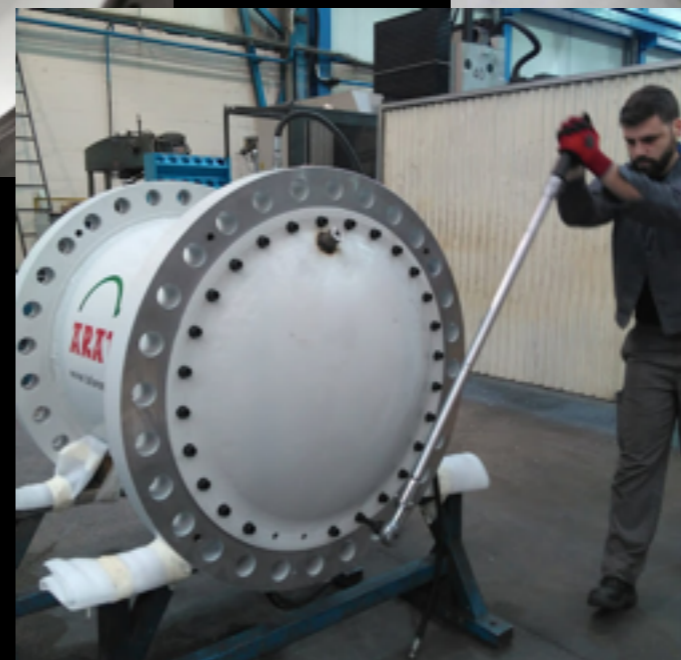
# 2018 HYDROSTATIC TESTS RESULTS

- Tests performed in Aratz facilities in Vitoria **12-21 Feb**, in a **dedicated pressure chamber** derived from water reservoir high-pressure turbine injectors that the company is producing
- Tested **complete pieces** of v.2 covers with 15mm-thick acrylic
- Water-tight **bagged**, protected by **foam** and **sealed**
- **Successful** test at 7 bar, minor deformations at 8 bar in an article.

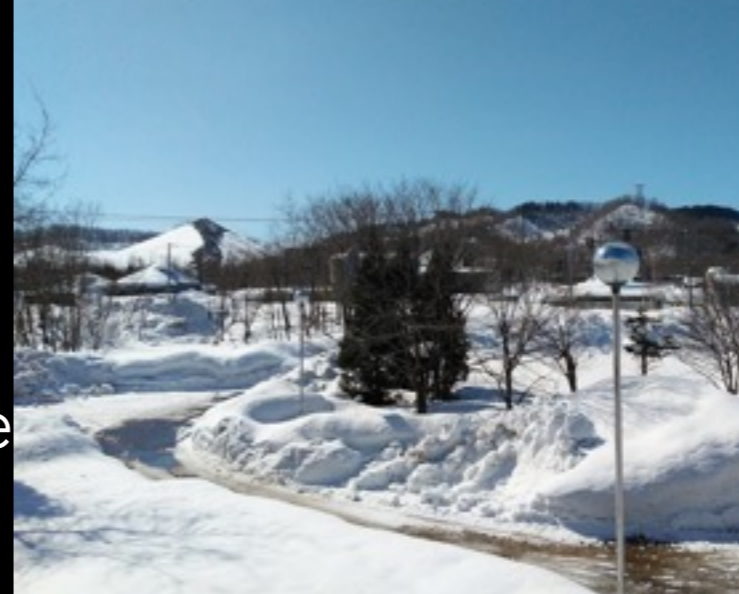
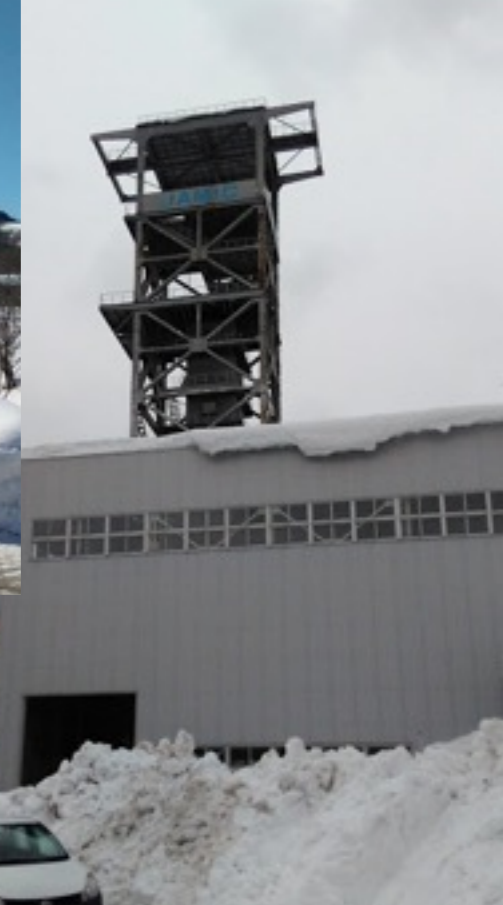
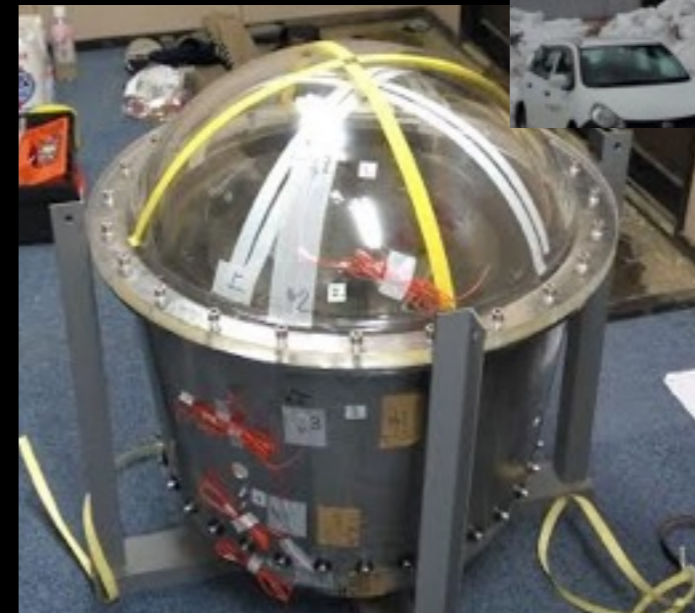
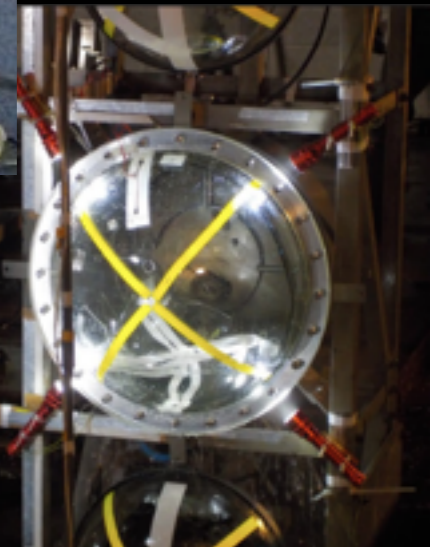
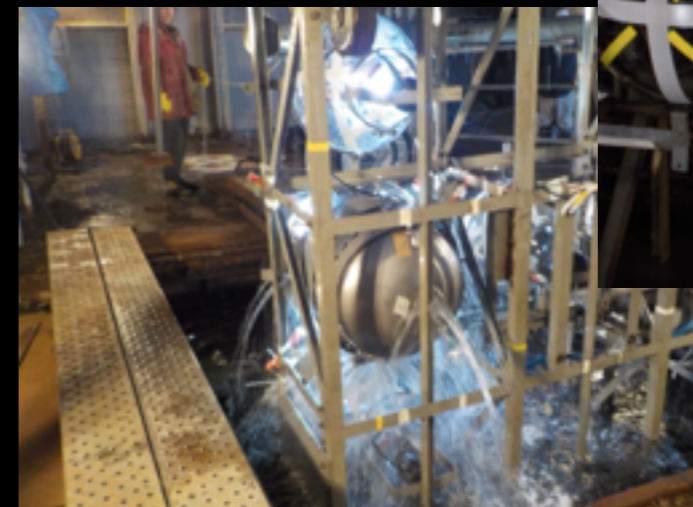
# IMPLOSION TESTS

- Tested together with Japanese SUS and re-cover designs in **Kami-Sunagawa's** (Hokkaido) ex-Japan Microgravity Center (**JAMIC**) facility (700m-deep pit flooded with  $\sim 12^{\circ}\text{C}$  groundwater)
- Assembled in-situ and paired with newly-made Kuraray **20mm** acrylic flanged dome
- Cover was instrumented with **6 pressure gauges**, tested at 60 m depth with 4 bare PMTs around it
- All PMTs survived a nominal shockwave **No deformation or damages** to cover or acrylic dome
