HYDROSTATIC AND IMPLOSION TESTS

**UAM-ARATZ "SPANISH"**  
STAINLESS STEEL COVER  
TESTING RESULTS

HQL 2018 - Yamagata, May 29th 2018

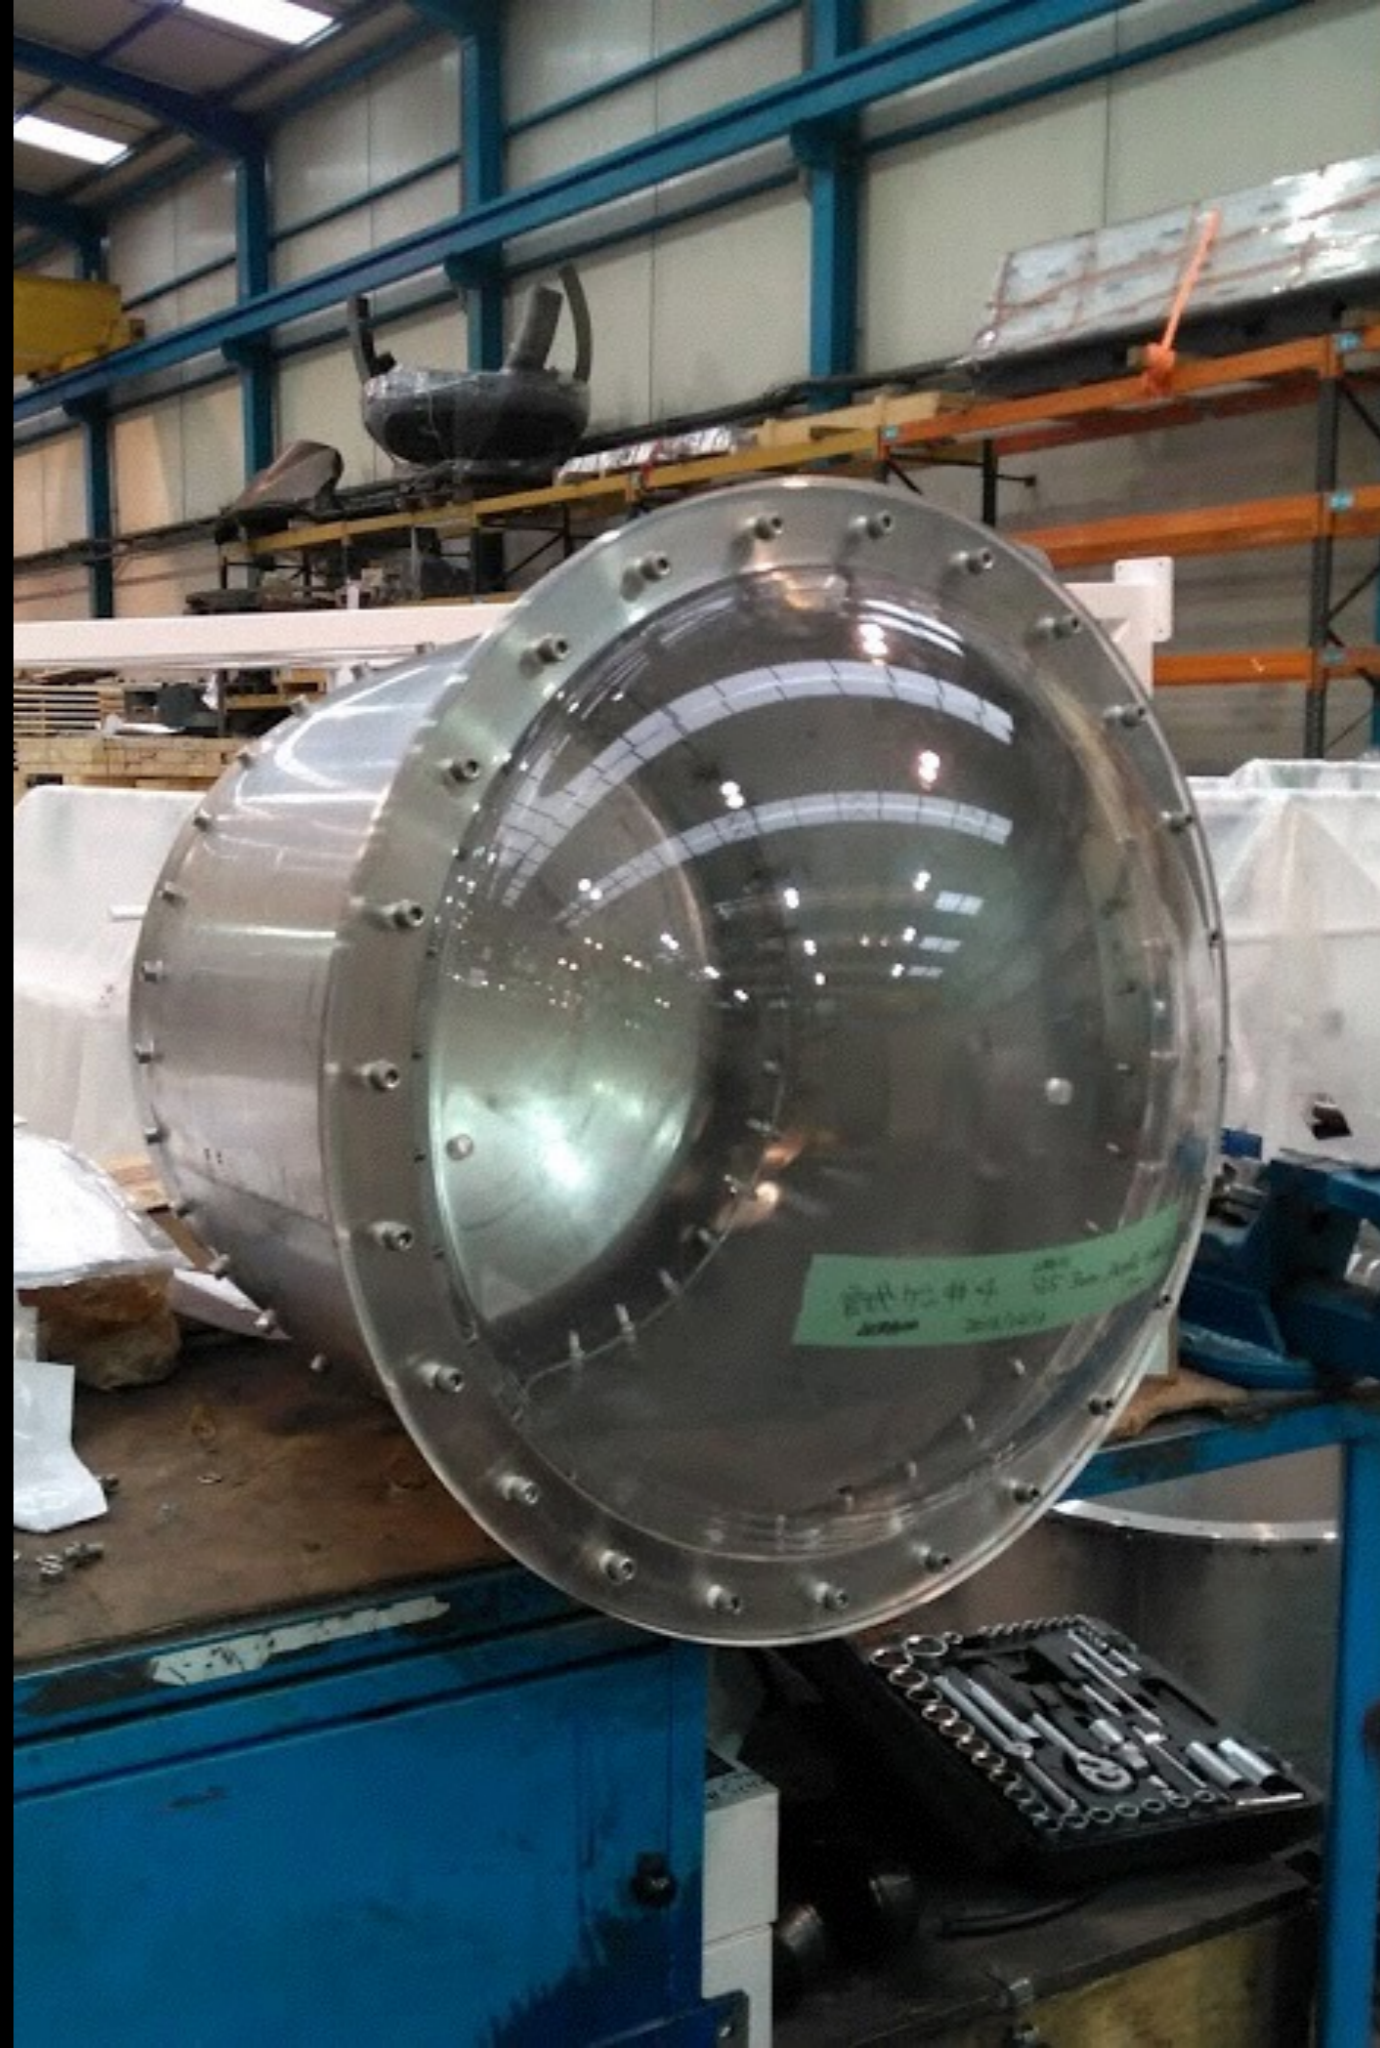
**Current design (30.7 kg)** is 2nd iteration

- **Single-piece, truncated-conical, welded "barrel"**
- **Strengthened welded bottom**
- Better force distribution through **wider connection washers**

Covers still developmental

- **Handmade bottom** with **large** tolerances.
- Room for optimization in **hole distribution**
- Beefed-up **top ring flange**
